CAPABILITY STUDY COMPOSITE MATERIAL FROM LEADING MANUFACTURER

Carbon Fiber Reinforced Polymer

February 22, 2021

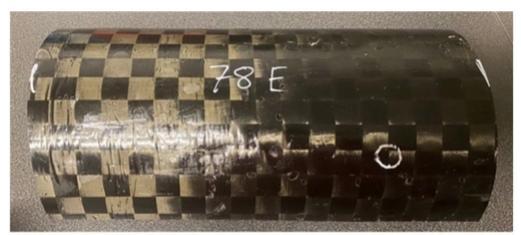
Figure 1: Sample inspected

A leading composite materials manufacturer provided dolphitech with Carbon Fiber Reinforced Polymer (CFRP) pipe sections for evaluation with the dolphicam2. The sample chosen for initial inspection was a half-pipe section with a circular marking denoting a flaw location. The pipe section was 2-4mm thick and 200mm in diameter.

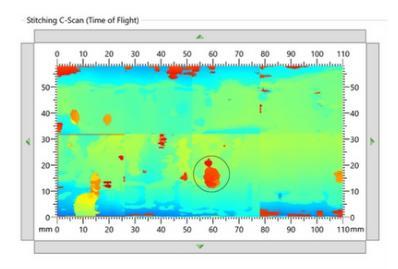
Figure 3: Stitched map of a small area of the sample, that covers the area where the indication was marked and a portion of the surrounding area.

The indication denoted by the circular marking was clearly resolved as shown by the stitched C-scan and single image captures. The stitched C-scan provides a useful overview of the whole condition of the pipe section including thickness measurements, while the single capture image is useful for taking detailed quantitative measurements. The indication can be clearly identified in all displays of the dolphicam2 software (A-scan, B-scans, C-scans and 3D view). Its planar dimensions and depth location can be readily resolved and measured. This is particularly useful for compound defects (shown above in figure 3), where different aspects of the defect extend at different through-thickness locations. The line measurement tool on the B-scan display is useful not just for flaw measurements, but can also be used for wall thickness measurement.

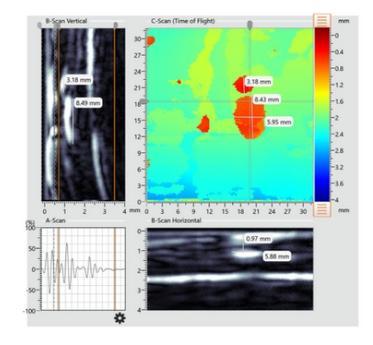
Figure 4: Sizing of the indication utilizing dolphicam2's native measurement tools
