IMPACT DAMAGE TO AN AIRCRAFT

Carbon Fiber Reinforced Plastics

May 25, 2019

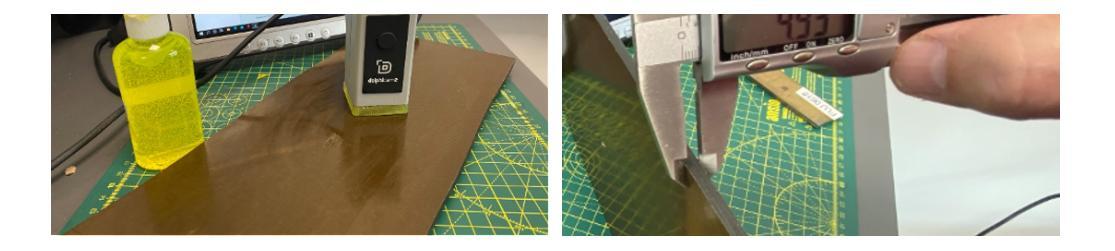
Boeing 787 Fuselage Skin Impact Damage

A sample was made available for inspection, with a induced impact damage. The image (below) is of the sample a 5mm thick Skin sample from a B787 aircraft.

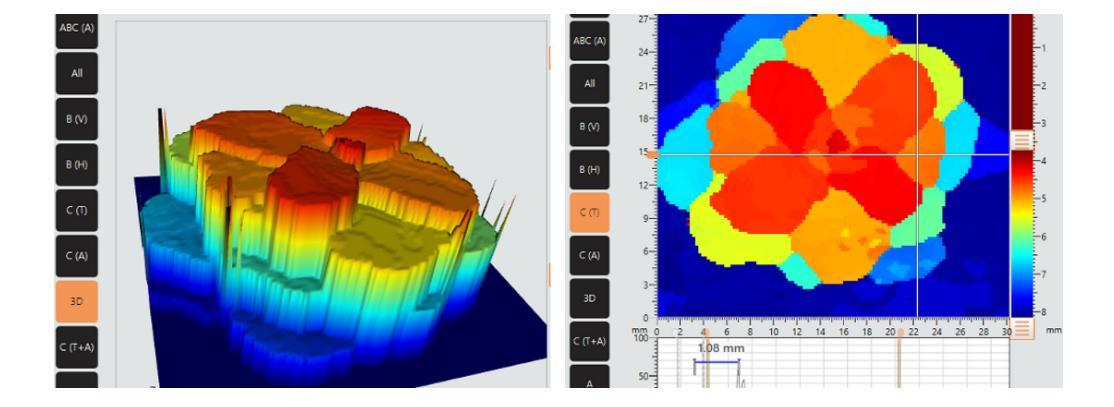
DOLPHICAM2 RESULTS

- The dolphicam2 was able to fully penetrate the material, identifying layers of material and impacted areas.

Impact damage on CFRP Aircraft skins and similar surfaces cause little or no change to the outer skin; sometimes this is called Barely Visible Impact Damage (BVID) and are hard to detect and evaluate.
However the dolphicam2 made it easy to screen for these traditionally hard to find indications in a time critical and highly regulated operation, where the decision has a huge safety and financial impact.
