CAPABILITY STUDY

GRP PIPE SECTIONS

Glass Reinforced Plastic

May 25, 2019

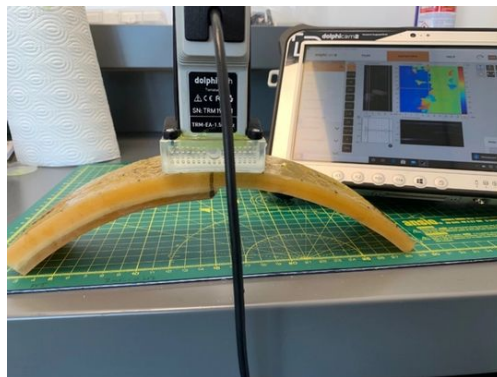
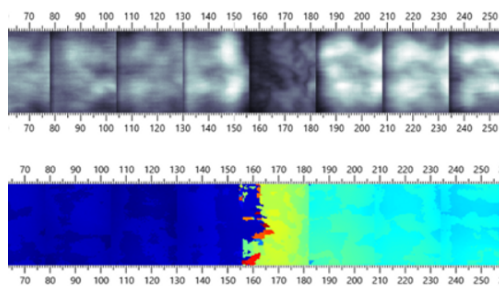
A TRM-EA-1.5MHz was used to inspect the pipe sections, with this low frequency providing confidence in the ability to penetrate through the thickness of all the pipe sections. This TRM has no delay line, instead a range of replaceable delay lines or curved pipe shoes can be mounted to the TRM. In this study 100-500mm diameter pipe shoes were used to match the different pipe sections. This ensured sufficient coupling was achieved for each inspection, which in turn enabled the sound to be correctly transmitted into the part.

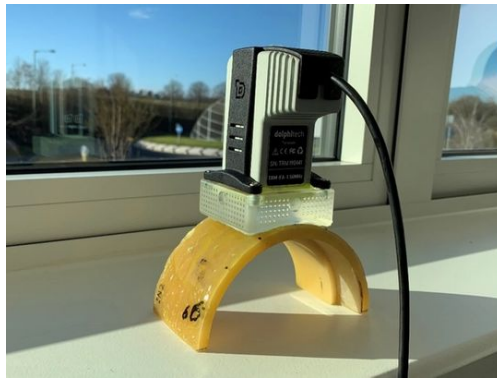
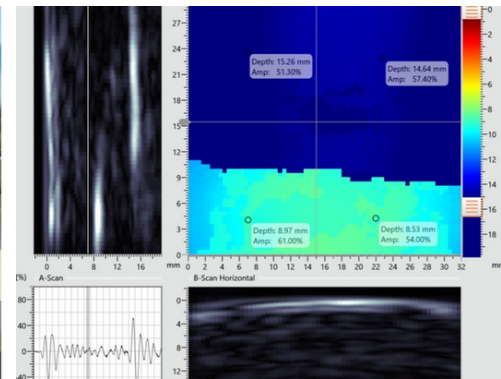
All the GRP pipe sections were successfully inspected, with reliable back wall echoes observed to the maximum thickness of 19mm. The thickness changes were quantified, and could be readily observed on the stitched Time-of-Flight C-scan images. The inner surface gouging was also well-resolved on the C-scan images, with shape of the damage and the wall thickness loss easily quantified in all instances.
