## CAPABILITY STUDY

# MONOLITHIC CFRP STEP BLOCK

Carbon Fiber Reinforced Polymer

May 25, 2019

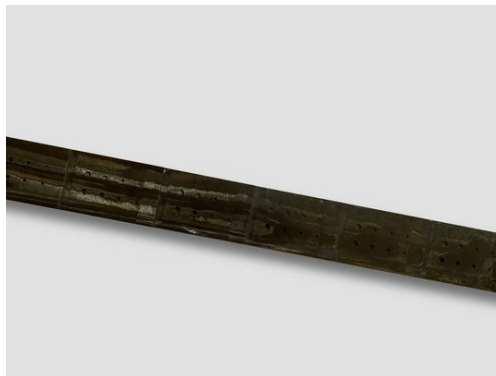
High quality composites are increasingly common in the aerospace industry due to their superior specific strength compared to metals. As such, Carbon Fiber Reinforced Polymer (CFRP) is the predominant material in the latest generation of both Airbus and Boeing airliners. Non-Destructive Testing (NDT) of CFRP is therefore critical to ensure both manufacturing quality and continued airworthiness of these aircraft. In order to assess NDT performance, reference blocks containing different features and geometry are commonly used, allowing detectability of different techniques to be compared. One such CFRP block was kindly provided to us by Airbus to benchmark the performance of the dolphicam2. It contains back surface steps of different heights, as well as flat bottomed holes of different heights and diameters. It can therefore be used to assess both the penetration and resolution capabilities of the dolphicam2.

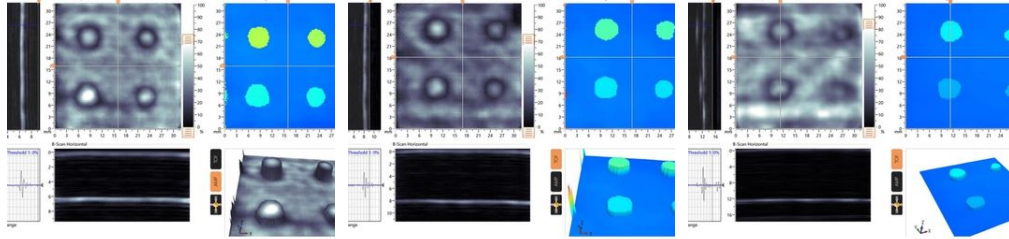
The dolphicam2 was able to resolve the back wall echo of the step block at all depths, showing successful penetration of the material. The majority of the flat bottomed holes machined into this surface were also resolved. The larger holes (4-5mm) were visible in the time-of-flight C-scan images (depicted in color), enabling easy interpretation of both their location and depth. Smaller holes (2-3mm) were not always resolved on the time-of-flight images. This is because they don't present a large enough flat surface to reflect the ultrasound. In these instances, the amplitude C-scans (depicted in grayscale) are often still able to resolve them, as they represent a variation in the amount of sound energy reflected. As both types of C-scan image are available in real time, the user can use both to enhance detectability.

The dolphicam2 with the 3.5MHz TRM was able to penetrate the full 16mm thickness of the CFRP step block, and resolve most of the flat bottomed holes, with real-time, color-coded interpretation of their depth.
