CASE STUDY

UNRIVALLED ULTRASONIC INSPECTION RESULTS FOR WIND BLADES

PROJECT OVERVIEW

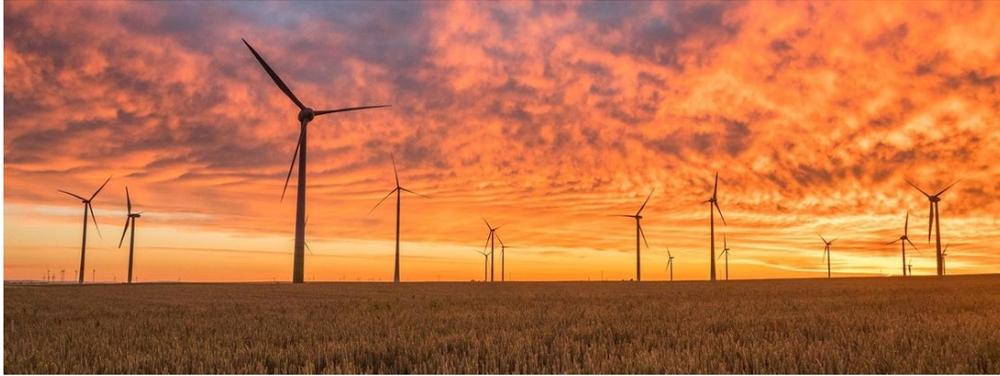
Different transducers can be used depending on the material type, area and thickness of the material being tested. This ensures that the most effective results are always achieved. During this specific project, a transducer TRM-EA-1.5 MHz used without a delay line, provided maximum penetration depth. This is required for the thick section glass fibre composites used in the construction of turbine blades.
