#EPRI-K1

BOILER TUBE DAMAGE KIT

Designed and Manufactured to Replicate Field Removed Specimens

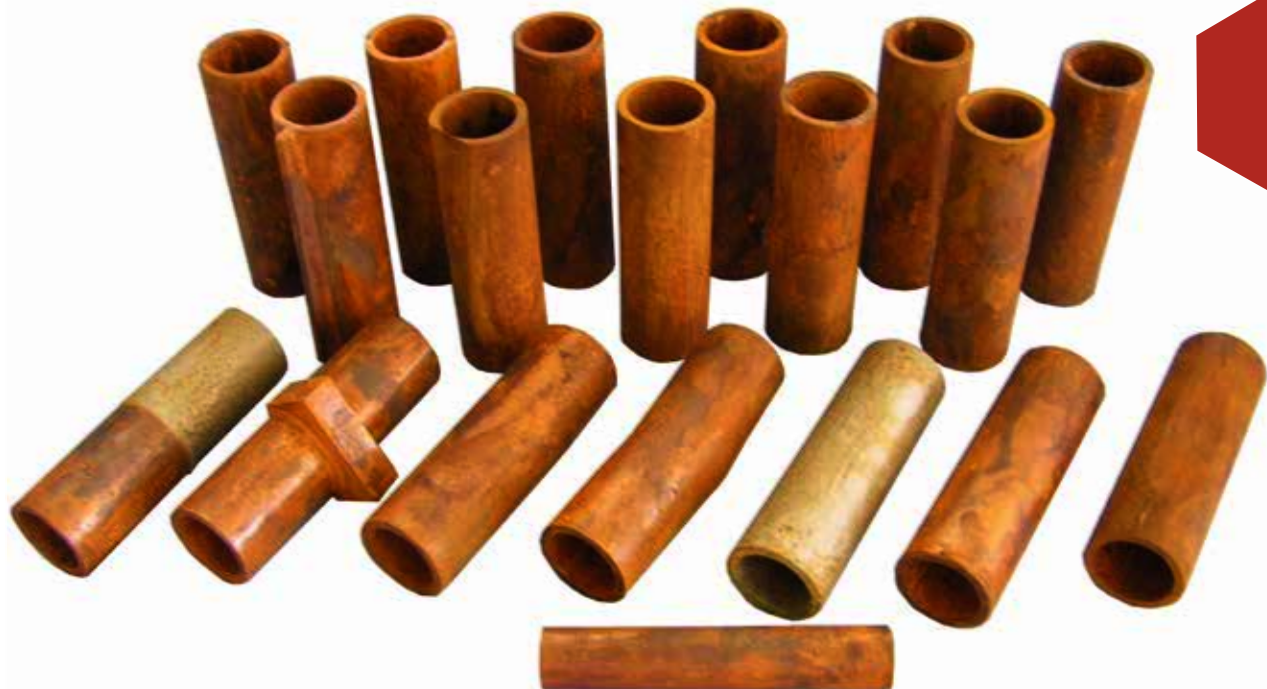
19 BOILER TUBES:

- Representing a complete range of fossil-fired boiler tube failure mechanisms steam and water touched.

- 18 Tubes At 2.5" OD X 0.25" Wall X 8" Long
- 1 Tube At 1.5" X 0.25" Wall X 8" Long

- 17 Tubes are SA513 T5 GR 1020/1026 CS
- 1 Tube is 304/304L
- 1 Dissimilar metal weld

- Long term overheating/creep
- Fire side corrosion (coal)
- Toe crack, stress corrosion (stainless)
- Soot blower erosion
- Fatigue crack (toe)
- Maintenance damage
- Pitting
- Rubbing / Fretting
- Chemical cleaning damage (thinning & pitting)
- Material flaw (forging lap)
- Corrosion fatigue crack
- Fly ash erosion, Hydrogen damage
- Acid Phosphate corrosion
- Caustic gouging
- Supercritical waterwall cracking (1.5" OD tube)
- Weld defects (lack of fusion and porosity)
- Graphitization
