Demonstration of Dakota DFX-8 Straight Beam Applications

The Dakota DFX-8 is 2 instruments in 1

INDEX STRAIGHT BEAM APPLICATIONS

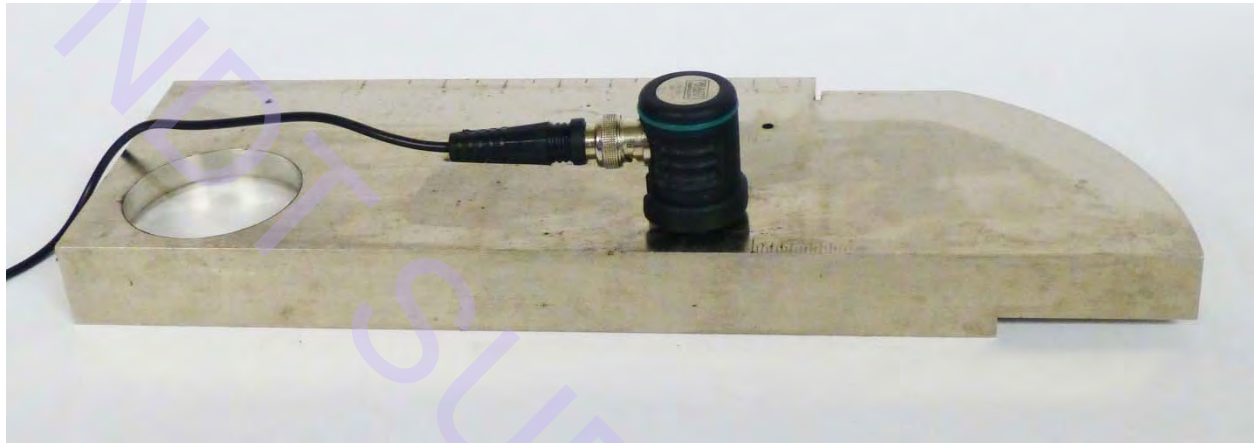
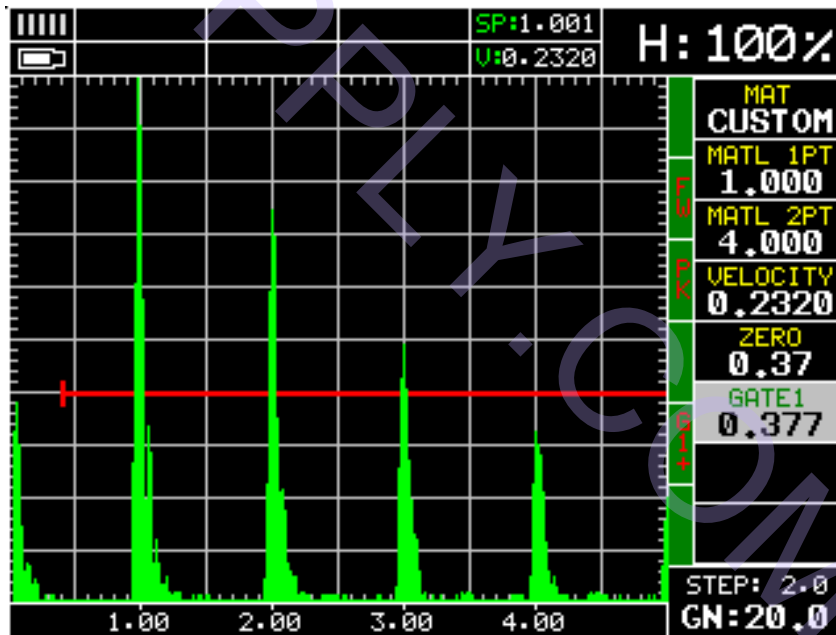
Straight Beam, 5 MHz, 3/4" Probe, 5" Range

1" Thickness of IIW Block

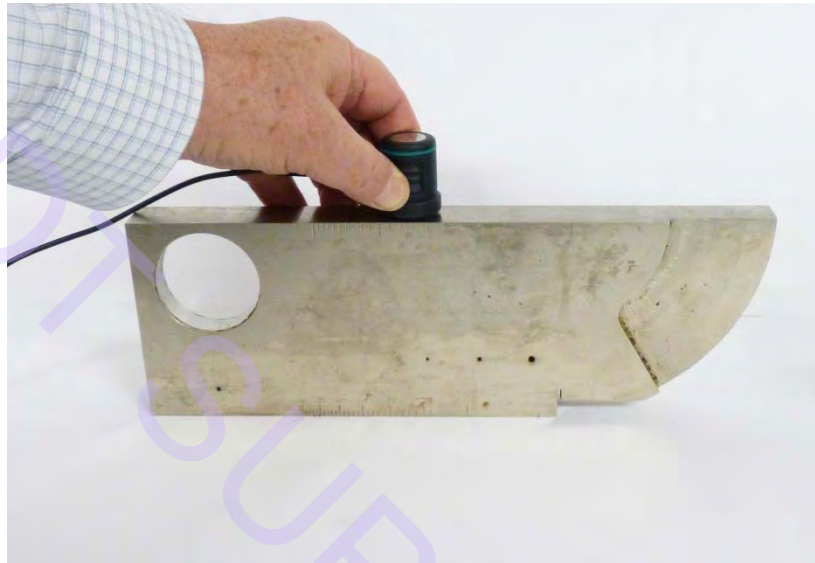
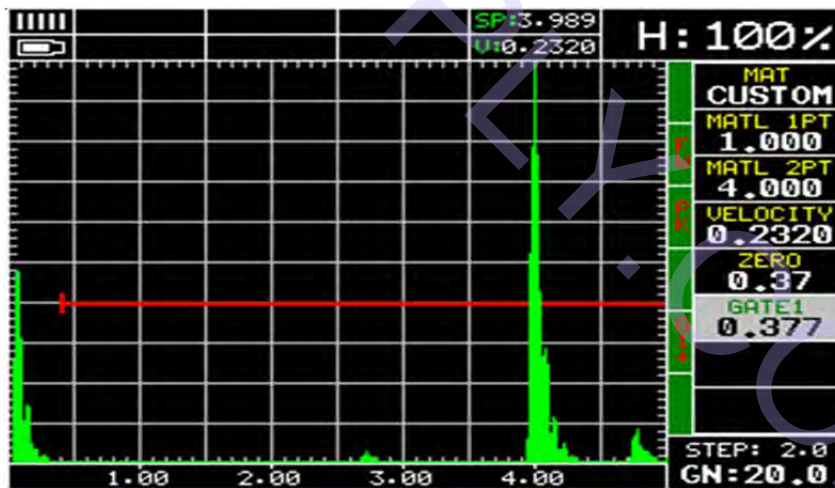
4" Thickness of IIW Block

Auto Cal using 2 known thickness 1" & 4"

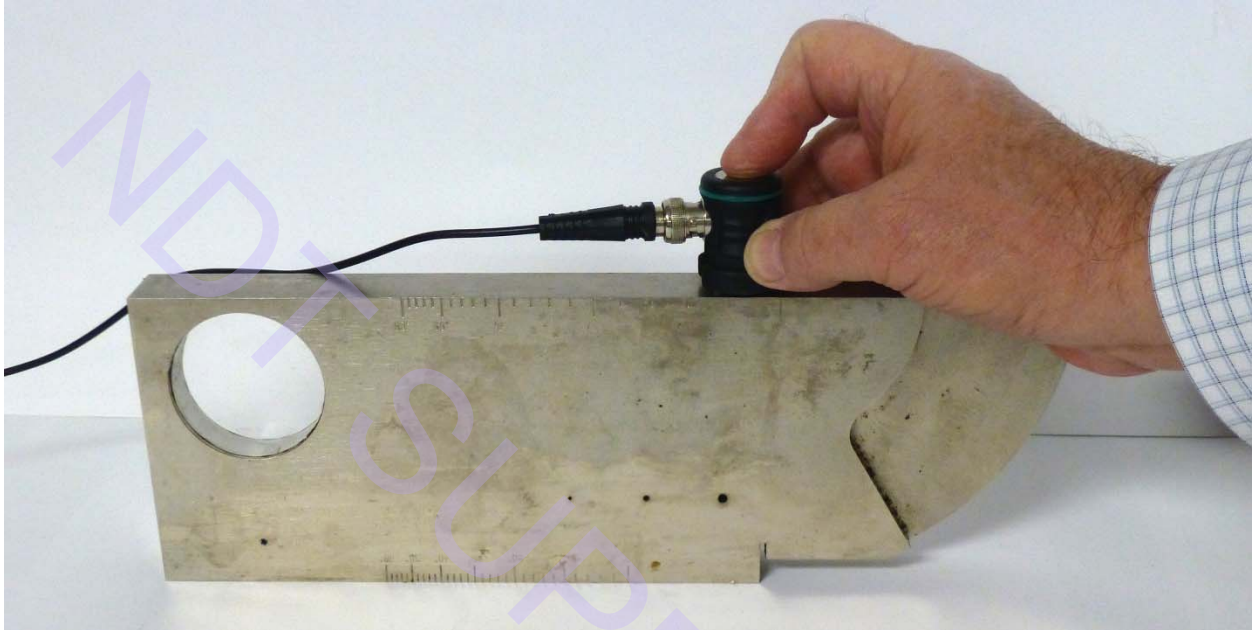
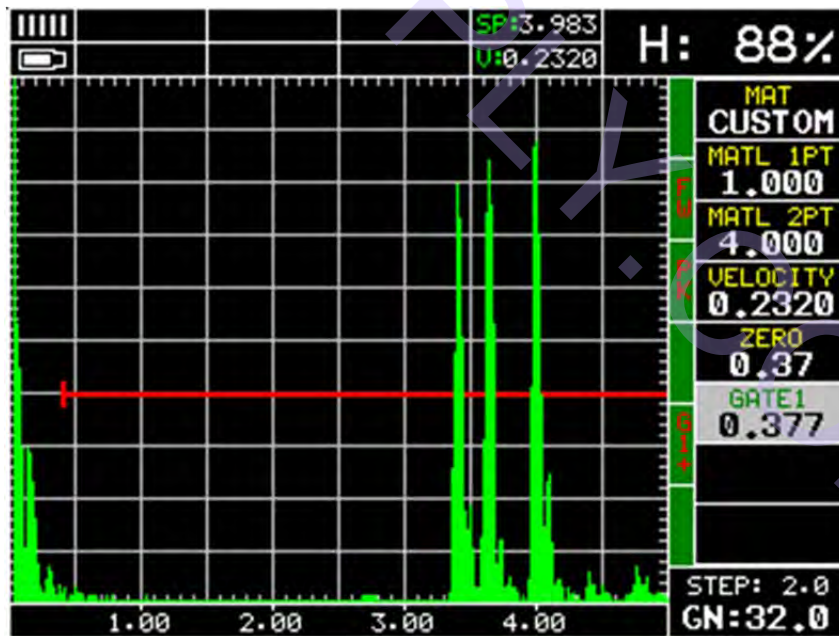
3.4 & 3.6" Resolution Notches in IIW Block

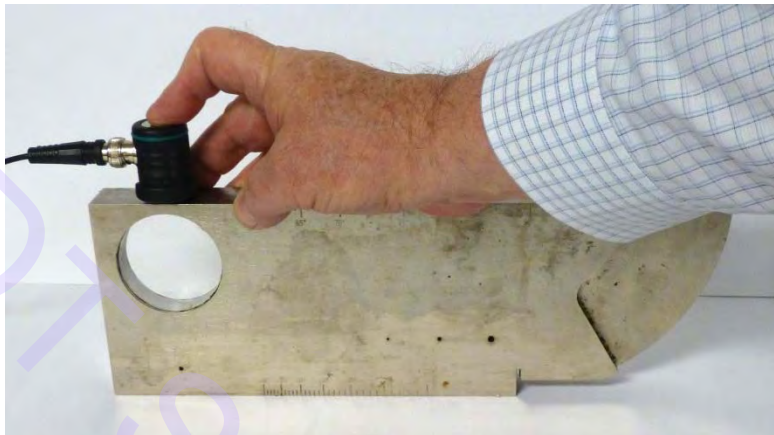
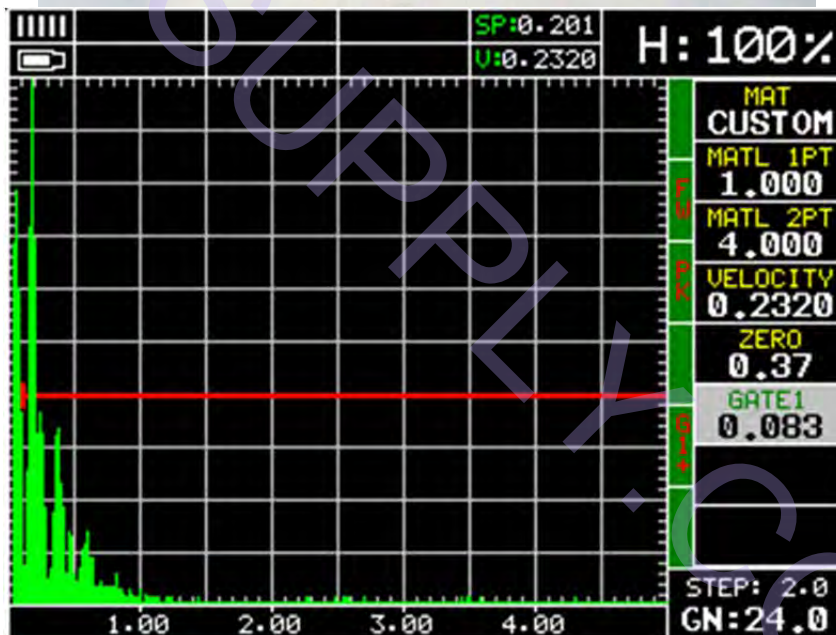
Resolving 0.200 Metal Travel Distance to 2" IIW Bore Hole

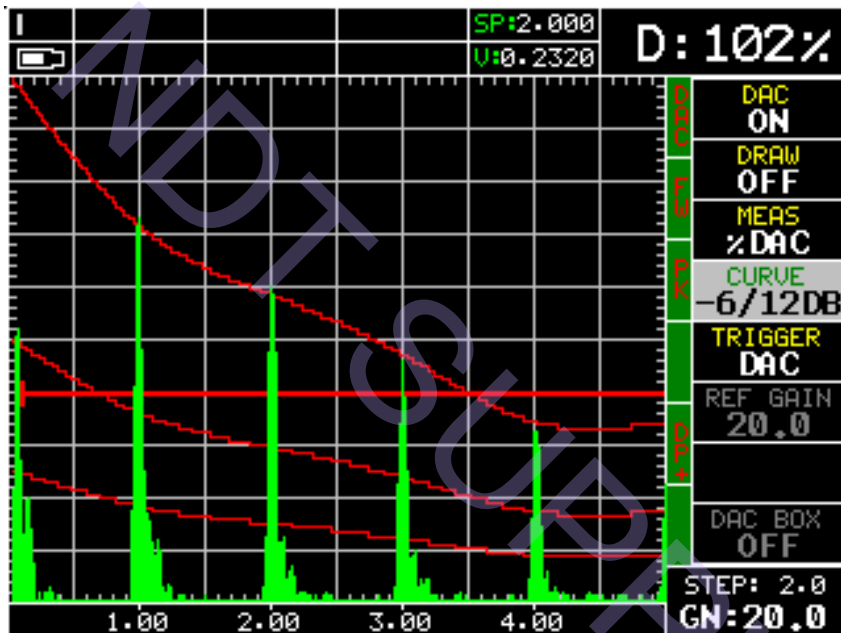
DAC using Straight Beam and 1" Back Wall Echoes

DAC Evaluation Straight Beam

DAC Curves can be set

- DAC
- +6/12 dB
- -6/+6 dB
- -6/14 dB
- -6/12 dB
- -10 dB
- -6 dB
- -2 dB

Trigger selections

- DAC
- GATE

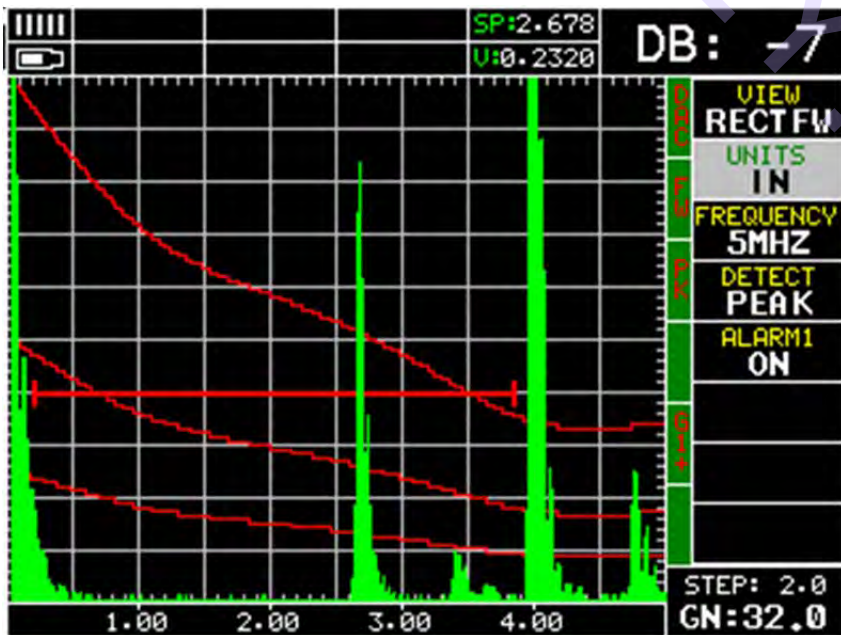
DAC EVALUATION

- DB
- % DAC
- % FSH

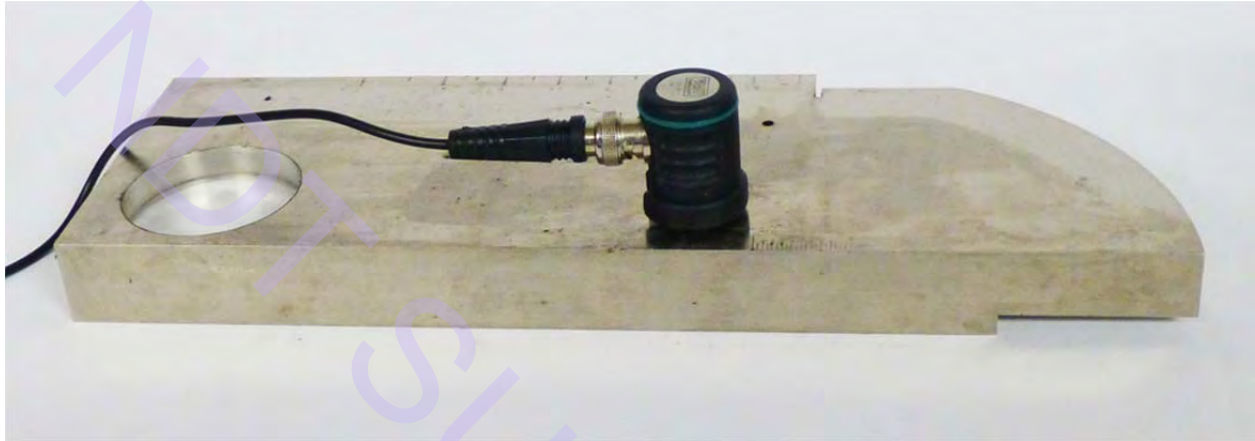
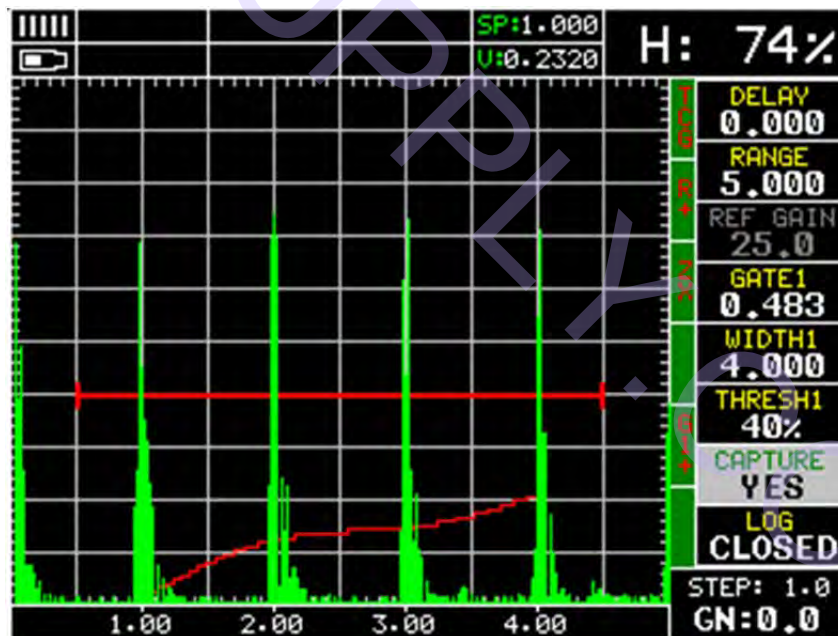
TCG Using 1" Back Wall Echo for demonstration purposes

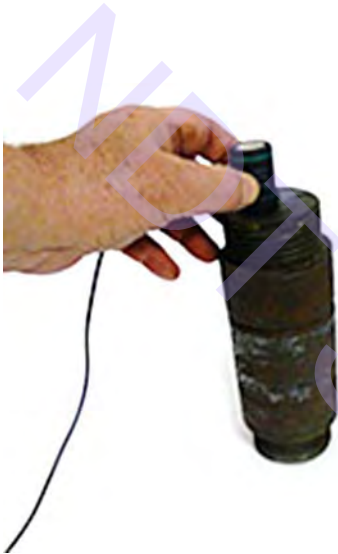
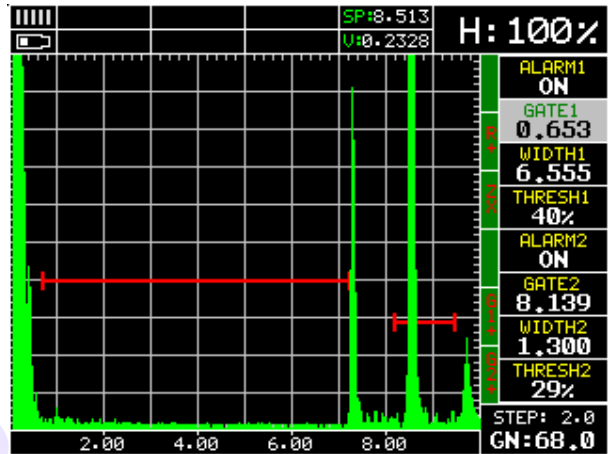
Bridge Pin
Straight Beam Probe

Good Pin Shoulder and End Echo

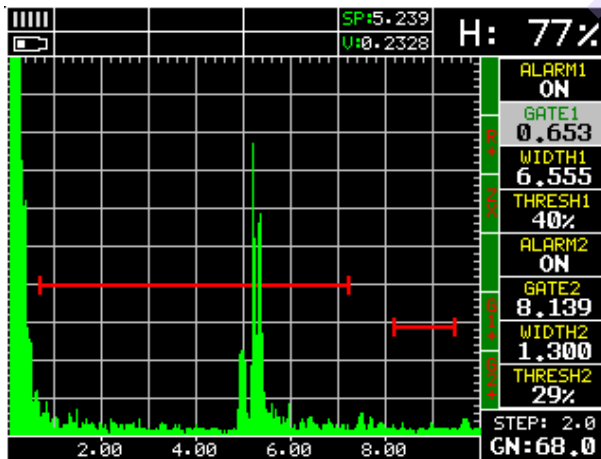
Cracked Pin – 2nd Zone Crack

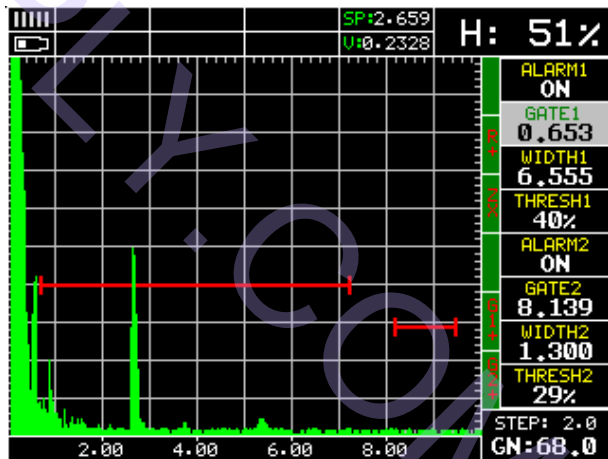
Cracked Pin – 1st Zone Crack

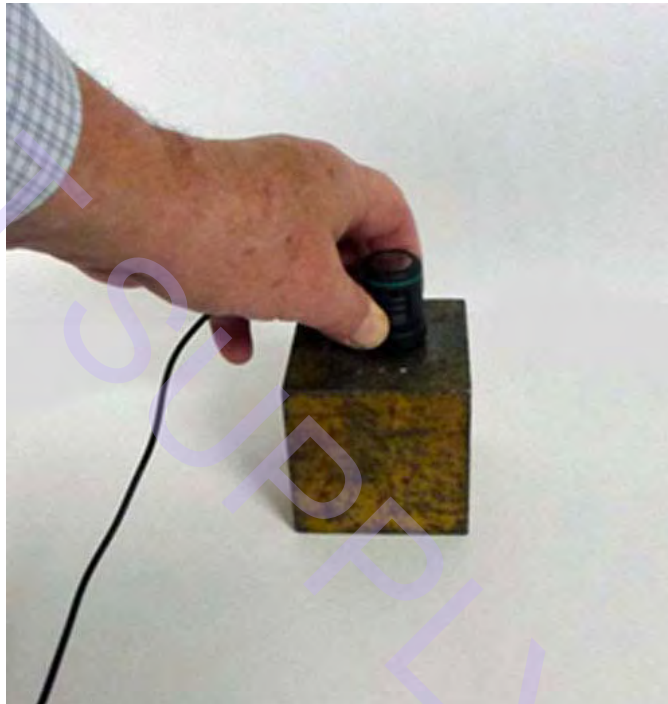
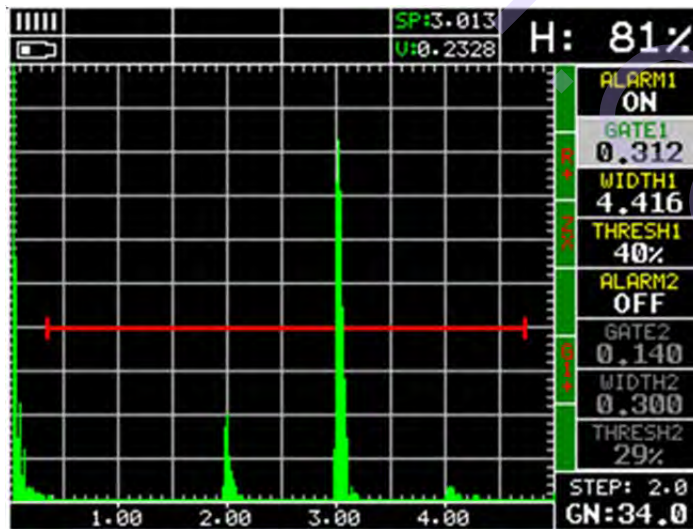
3" Steel Block with Flat Bottom Hole Straight Beam

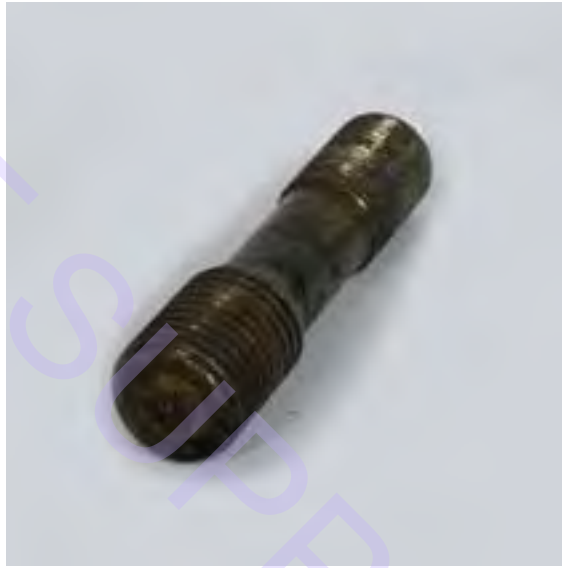
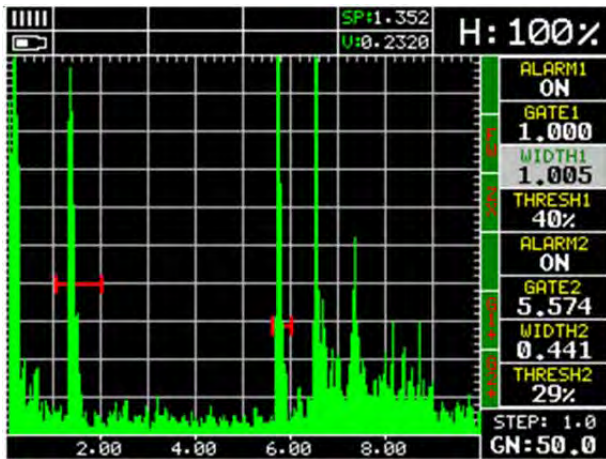
Gas Compressor Bolt with Crack Straight Beam Test

Calibration Bolt

Showing both Saw Cut and Back Wall Echo

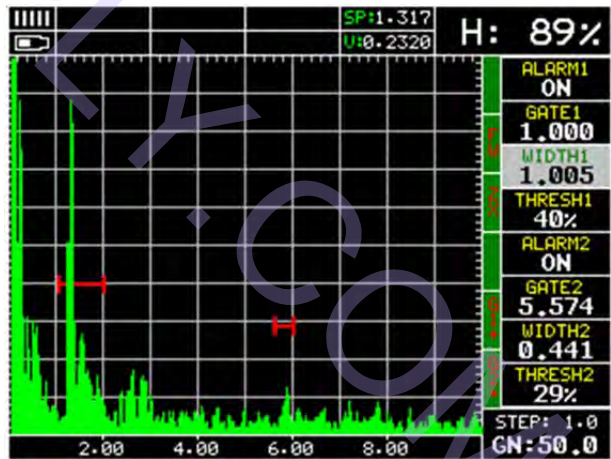
Cracked Bolt

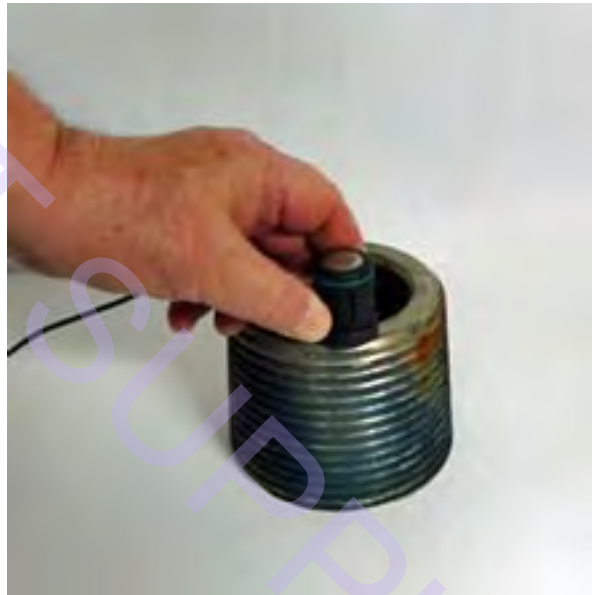
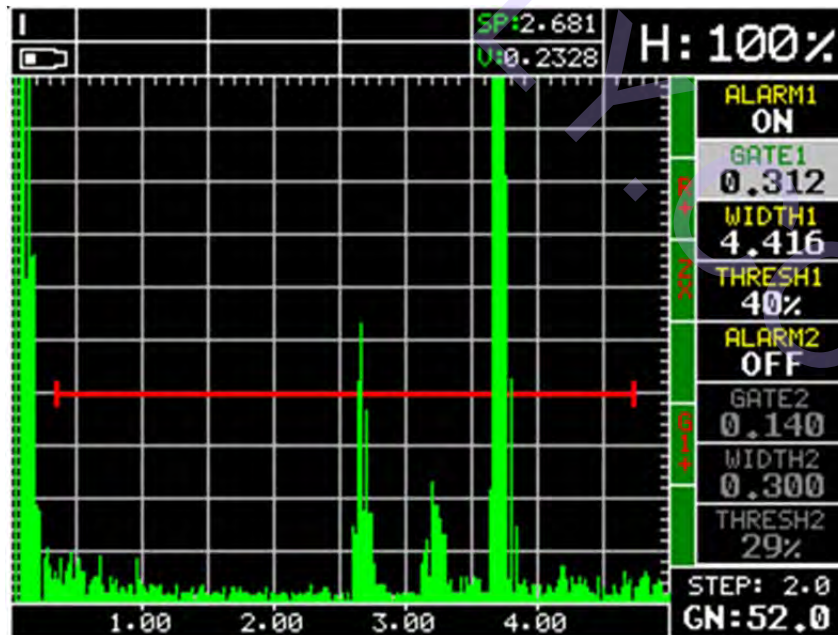
Drill Stem with Thread Cracks

Small crack at 2.6" & 3.3" note: no loss of Back Wall Echo

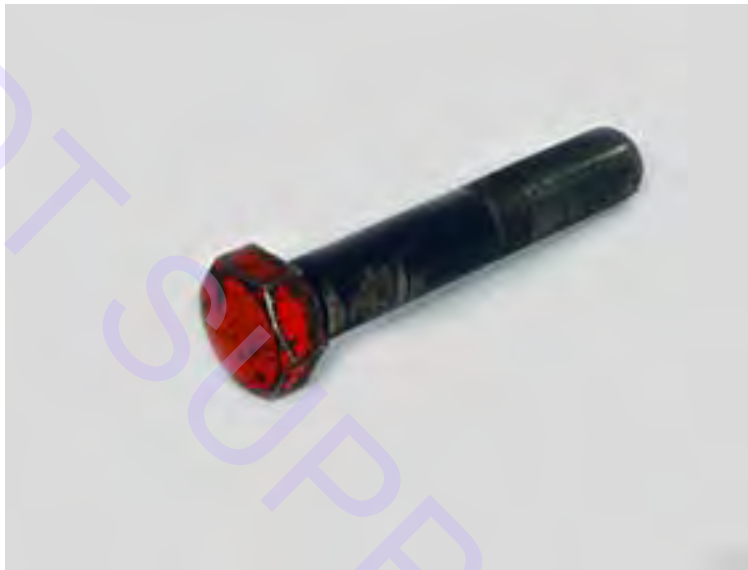
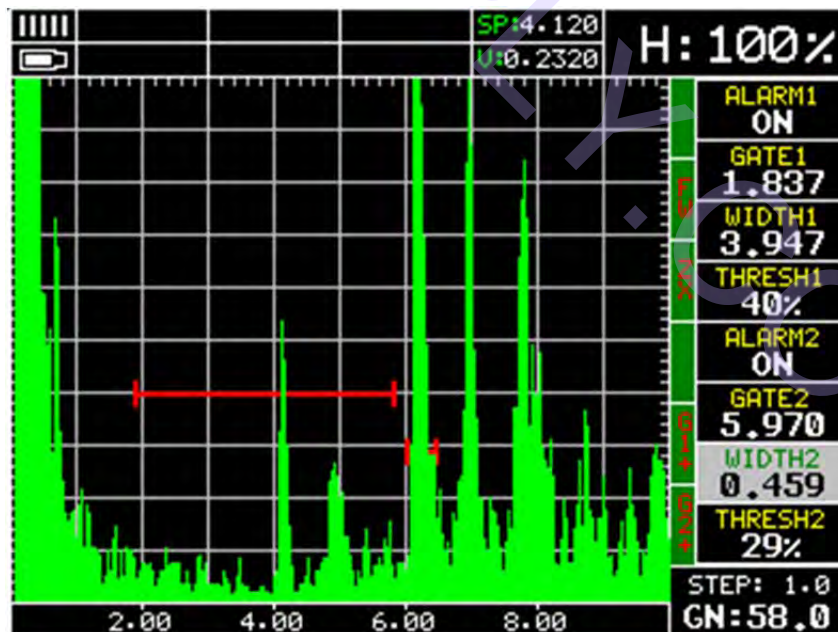
Cracked 6" Machine Bolt
Straight Beam

6" Bolt with Crack at 4", note strong Back Wall Echo

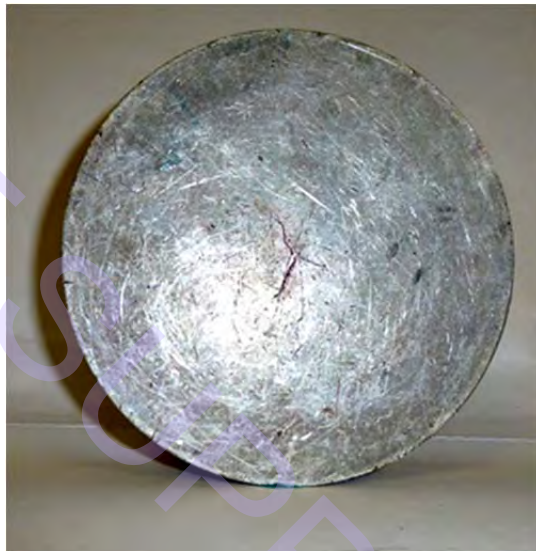
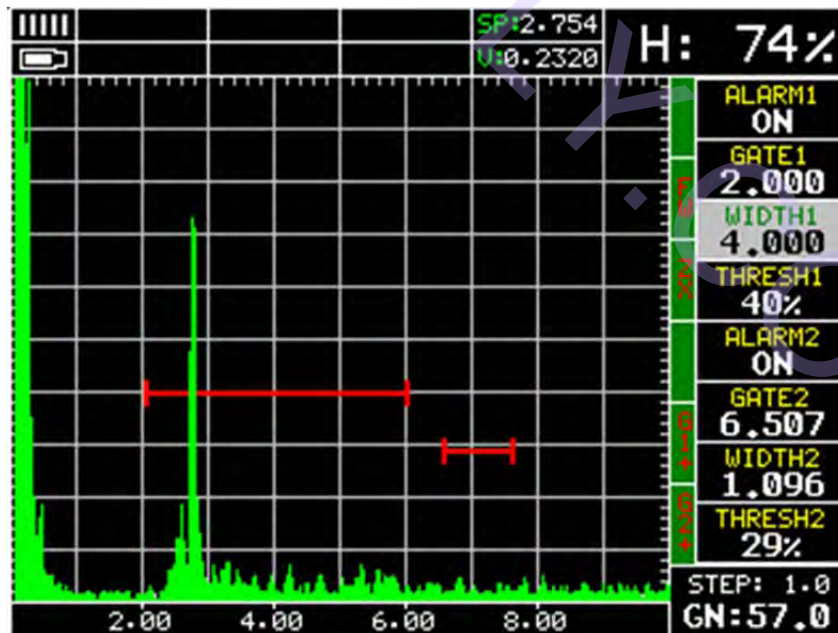
Aluminum Billet with Centerline Crack
Straight Beam

Centerline crack, note complete loss of Back Wall Echo

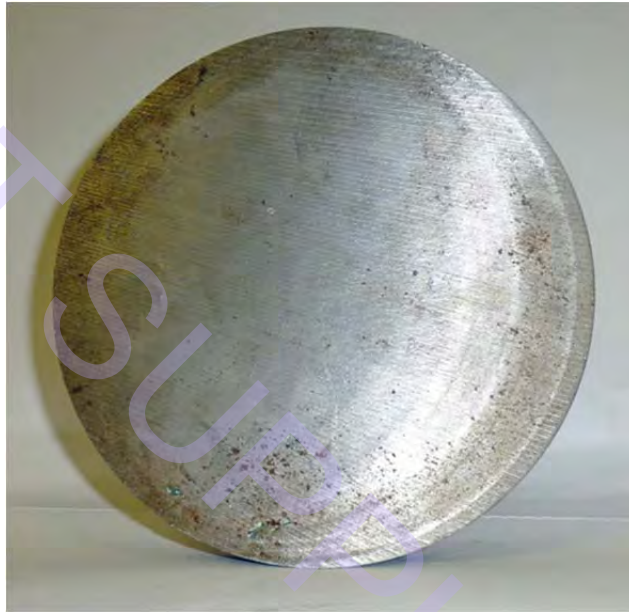
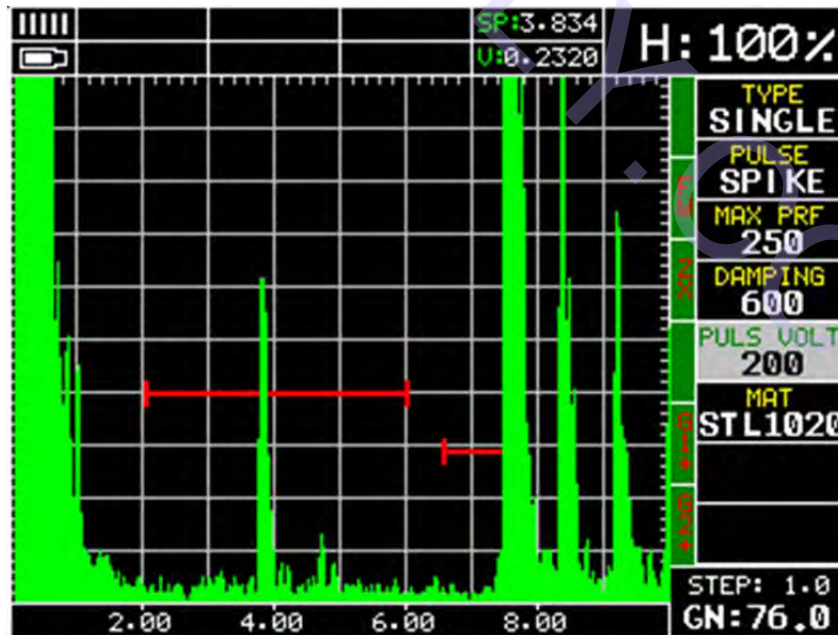
Section of Railcar Axel with small Centerline flaw
Straight Beam

Flaw at 3.8" no loss of Back Wall Echo

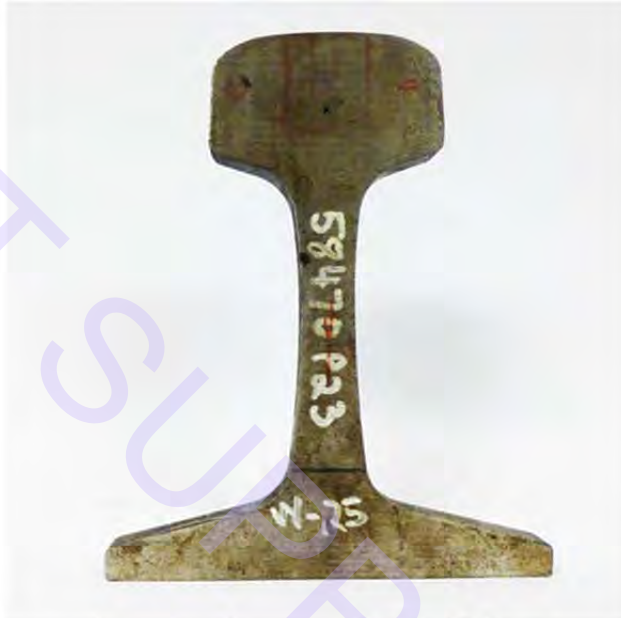
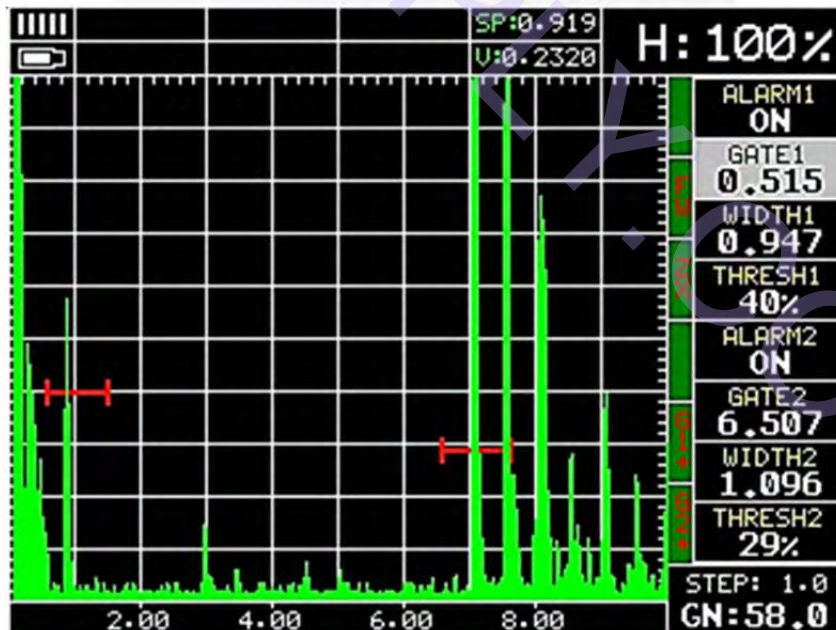
Rail with Head Piping
Straight Beam

Flaw at 0.9" no loss of Back Wall Echo

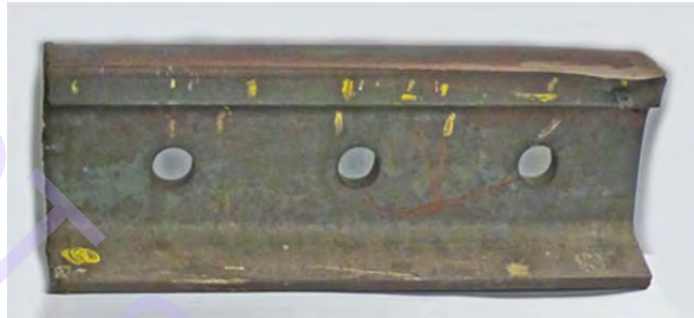
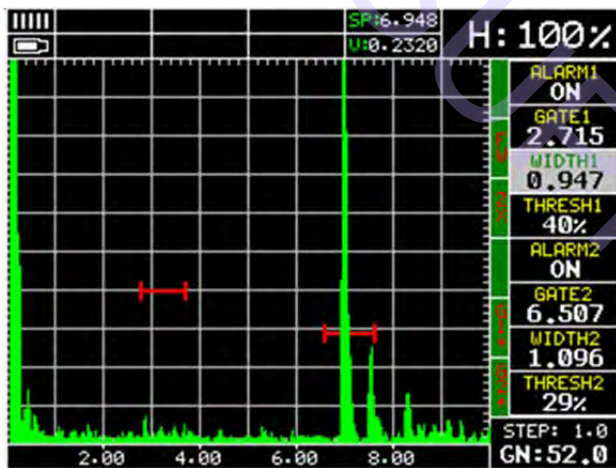
Good Section of Rail

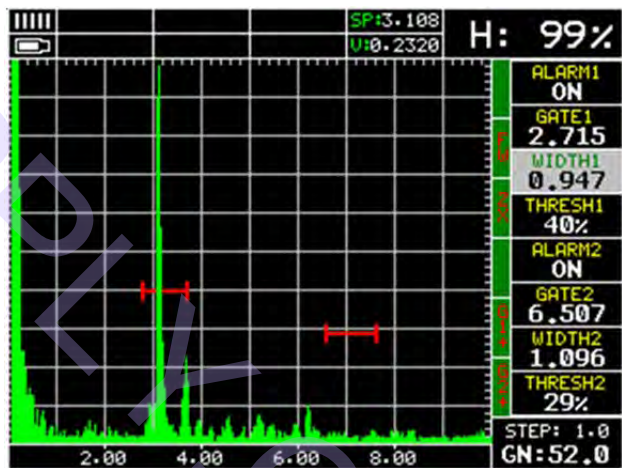
Good Bolt Hole

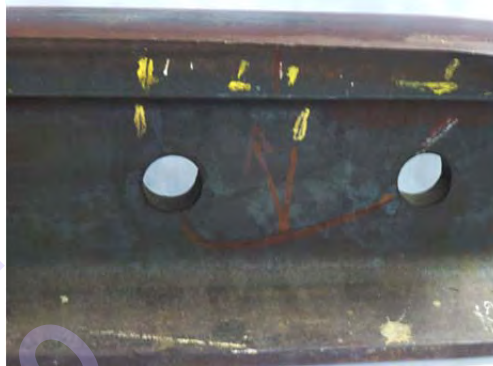
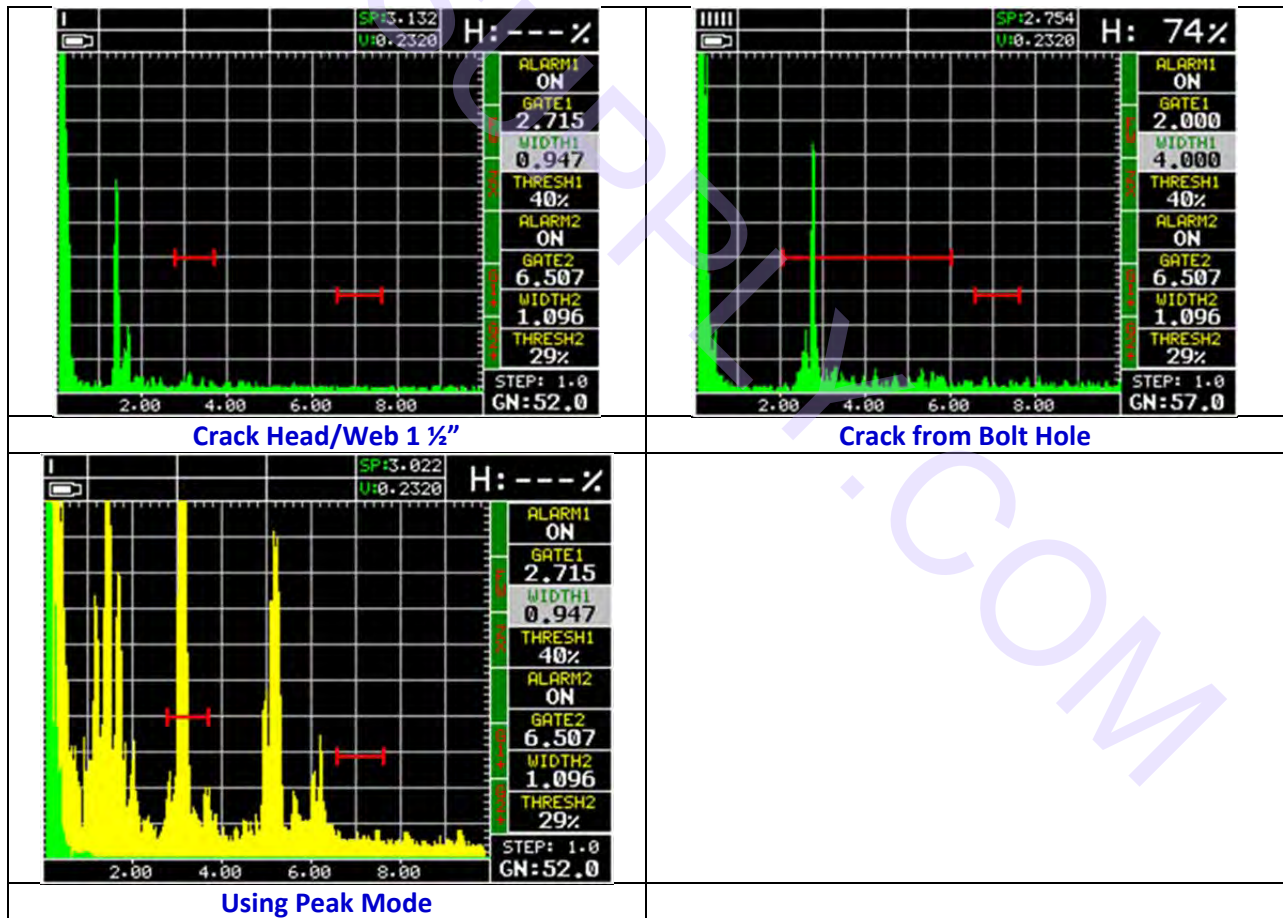
Bolt Hole Cracking

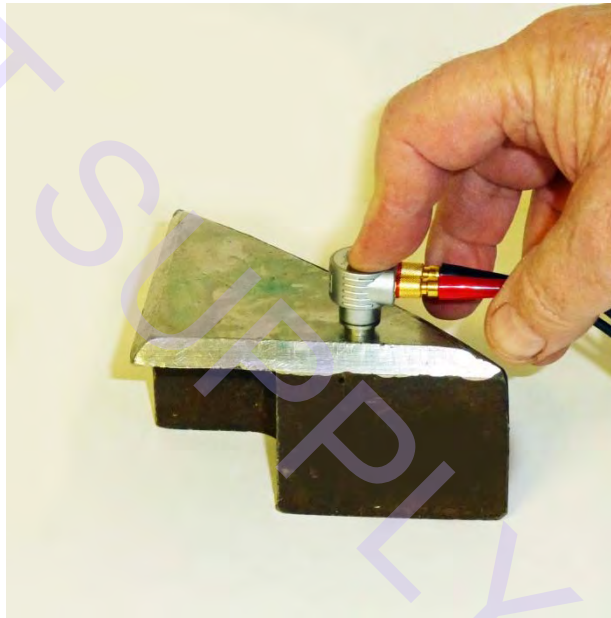
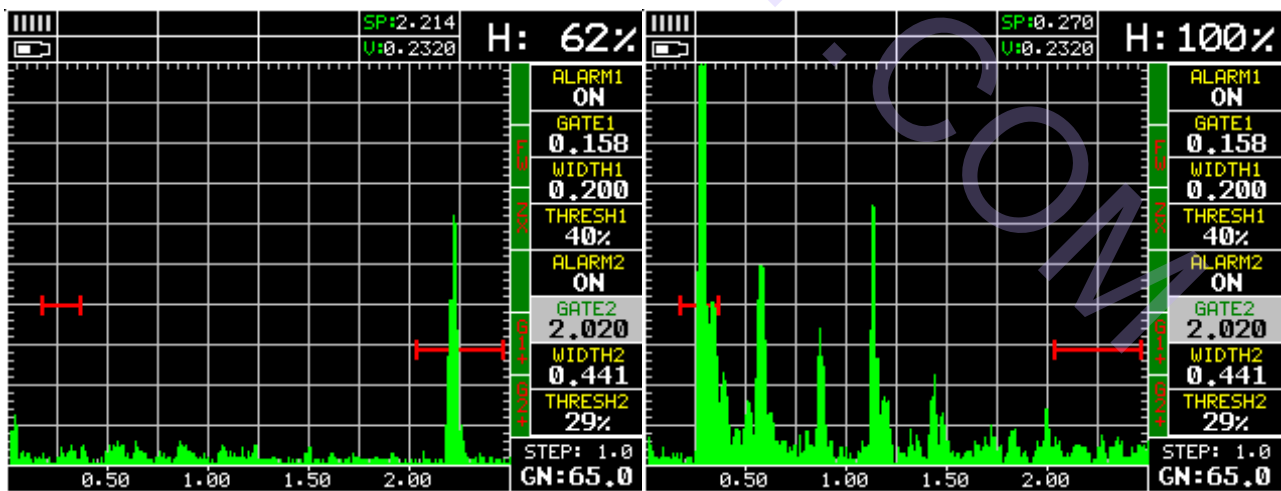
Bond – Weld Cladding Stainless Steel to Carbon Steel
Dual Probe

Good Bond
Back Wall Echo at 2.2"

Un-Bonded
Signal at 0.27"

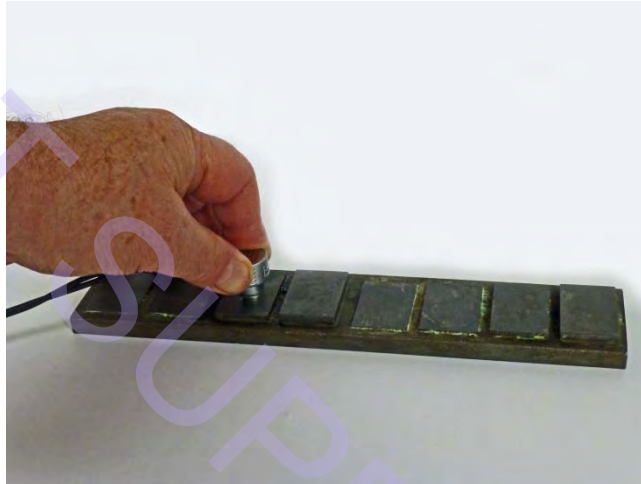
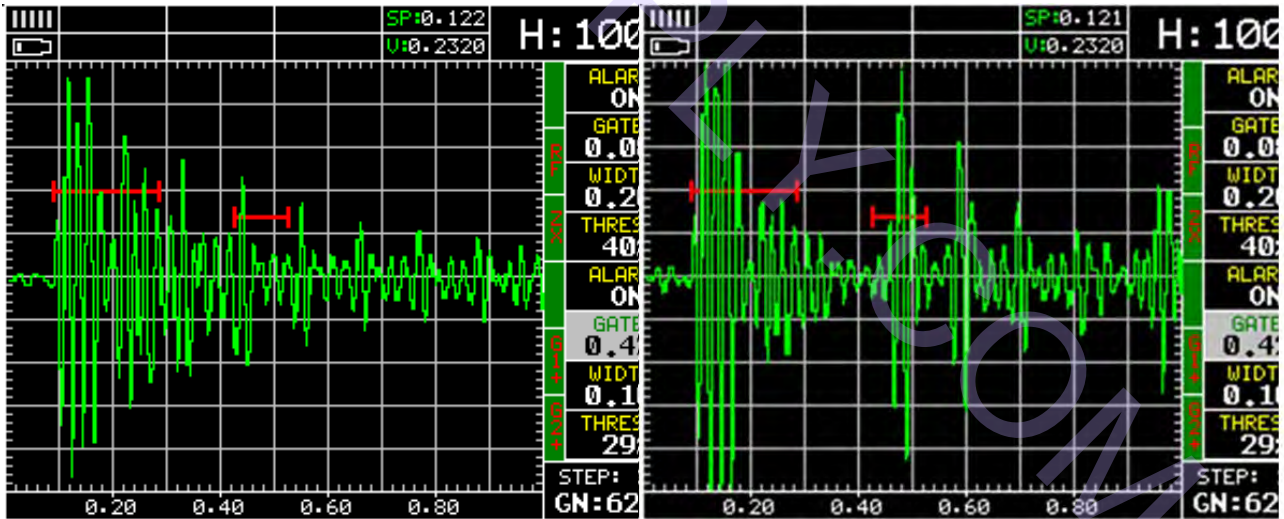
Silver Braze Tungsten Carbide to Steel
Dual Probe

Disbonded
No Back Wall Echo

Bonded
Good Back Wall Echo

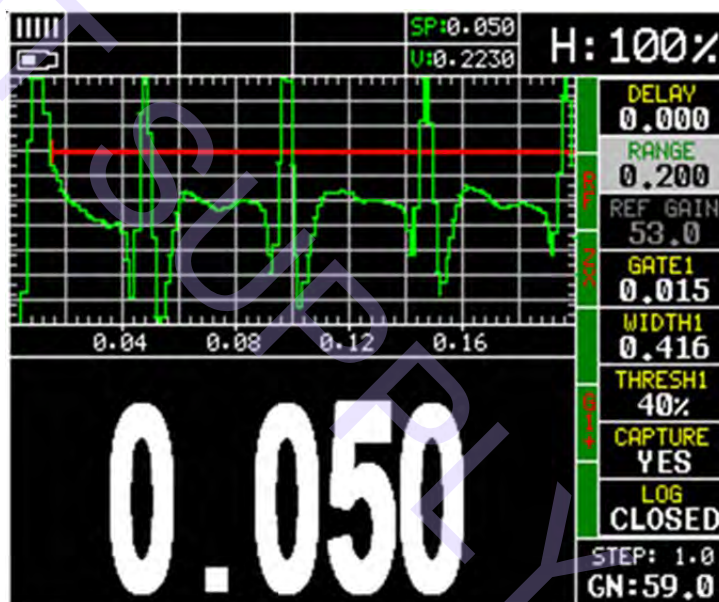
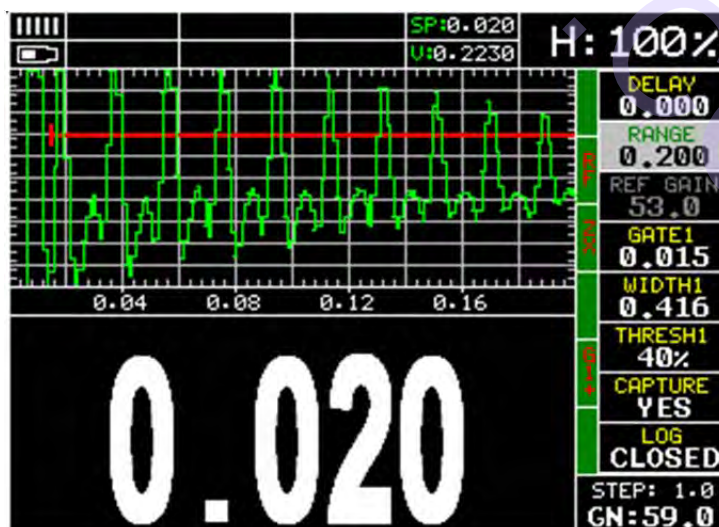
Thickness Measurement with 10 MHz Delay Line in Flaw Mode 0-1st Echo
Measurement
